**FIFTH FIVE-YEAR REVIEW REPORT FOR
SILVER MOUNTAIN MINE SUPERFUND SITE
OKANOGAN COUNTY, WASHINGTON**

**U.S. Environmental Protection Agency
Region 10
SEATTLE, WASHINGTON**

**Washington State Department of Ecology
Central Regional Office
YAKIMA, WASHINGTON**

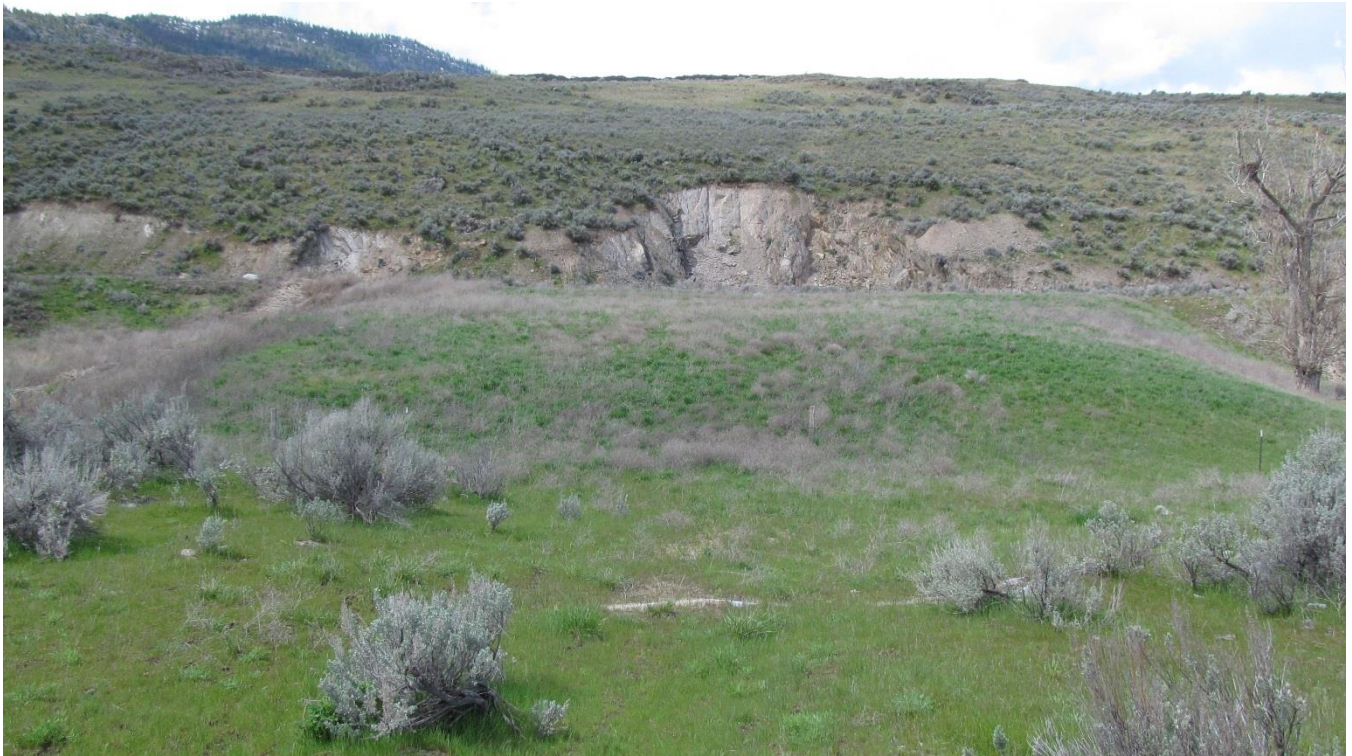
Photo 1: Tailings Cap and Sealed Adit – from the east

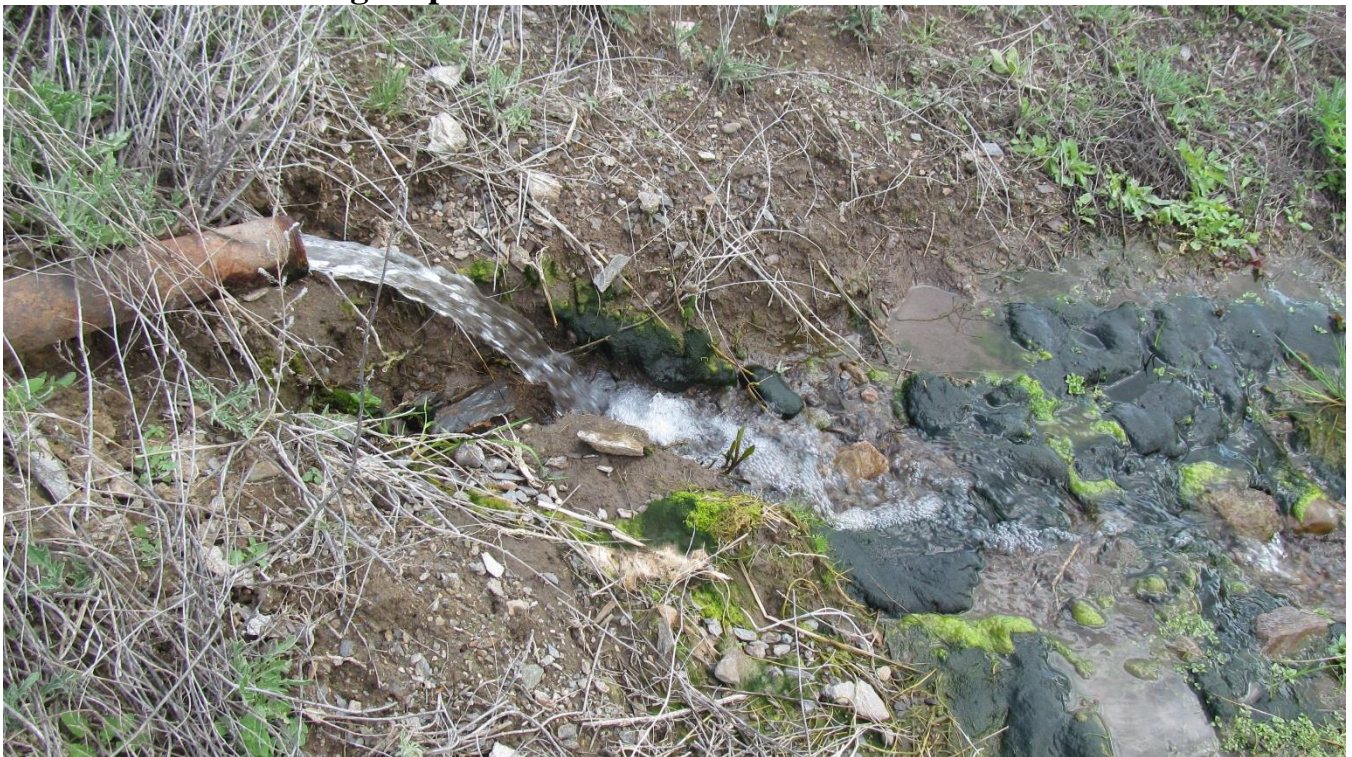
Photo 2: Mine Drainage Pipe – from the west

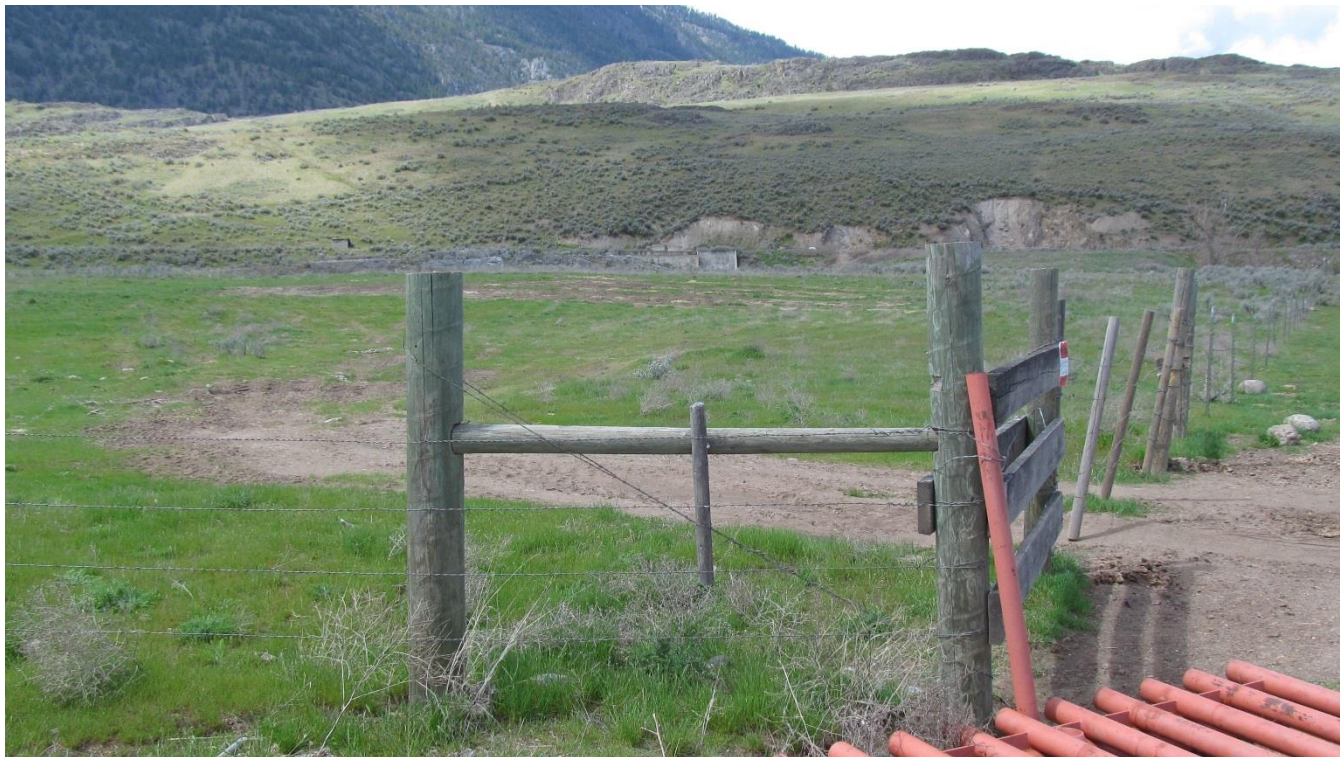
Photo 3: Site Entrance Fence and Gate – from the east

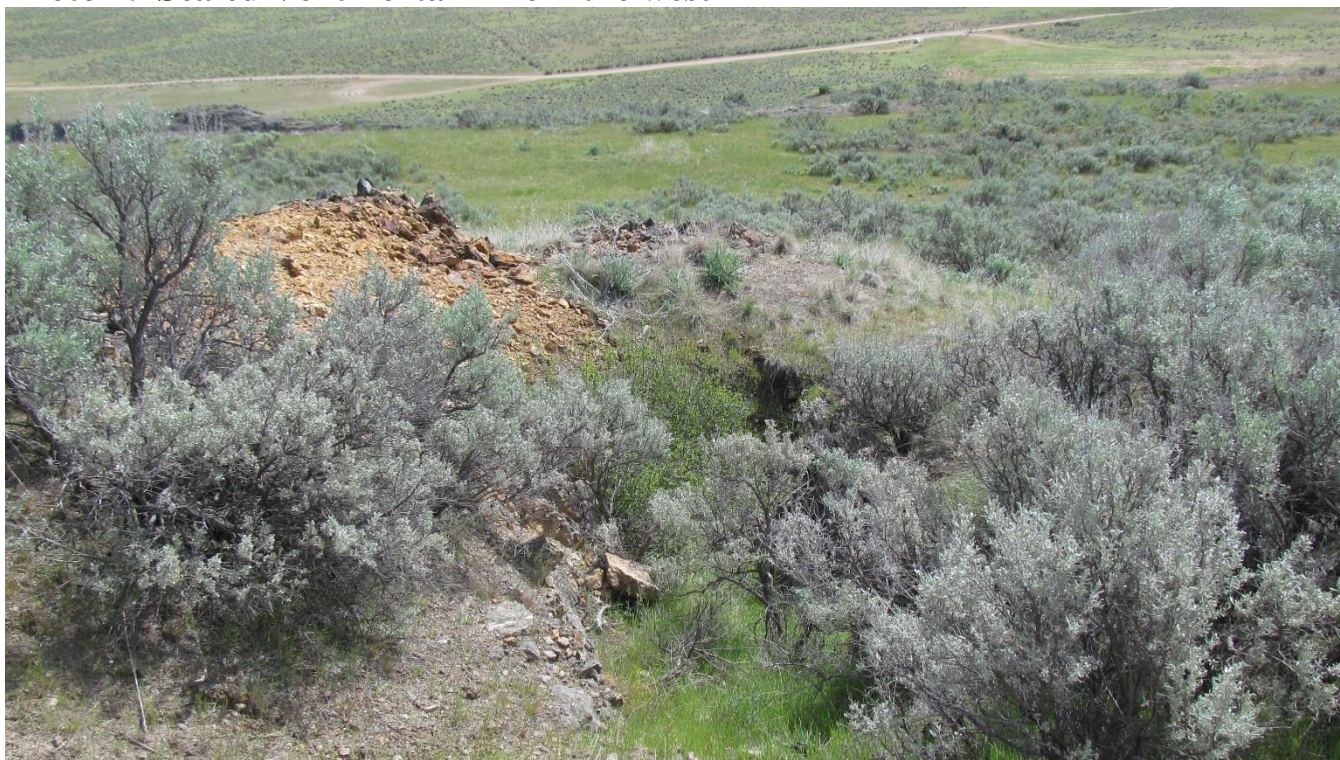
Photo 4: Sealed Vent Portal – from the west
